Manhole Inspection Summary

Manhole # S31AA_031MH

Insp Date: **12/14/07 12:48 PM**

Location Address: **420 ORCHARD ST**

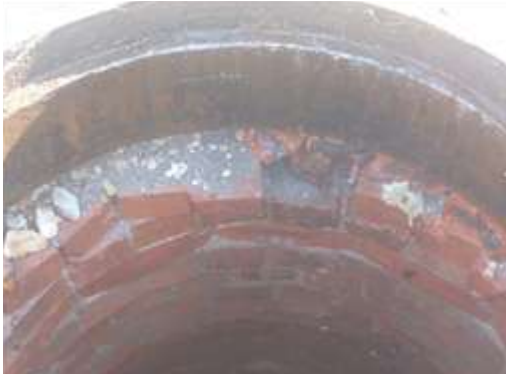
Defect 2

Condition: ☐ Sound ☐ Cracked ☐ Root Intrusion ☒ **Loose Brick** ☐ Deteriorated

LOOSE CHIMNEY BRICKS

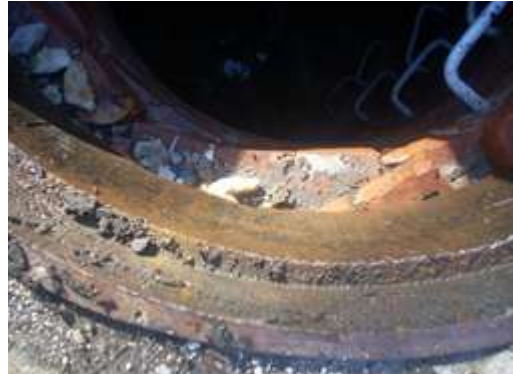
Defect 1

Offset: **2** (in.)

FRAME OFFSET

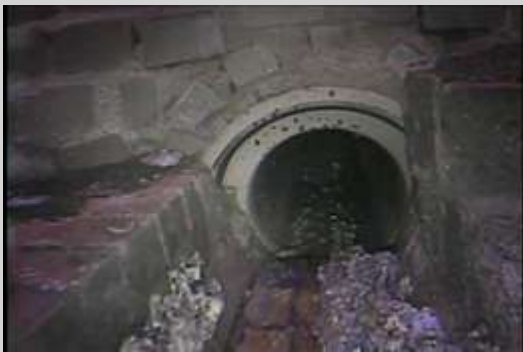
12 O'Clock Outflow

8 in. Circular Gravity Sewer
Pipe Out @ 12 O'Clock

Pipe Height: **7.2** (in.) Rod and Bar (Angled)
Pipe Material: **Clay** ☐ Pipe Lined
Invert Depth: **11.84** (ft.) Flow Characteristics: **Slow**
Deposits: ☐ None ☐ Mud ☒ **Sludge** ☐ **Debris** ☐ Grease
Silt Depth: **1** (in.) Deposits Extent: **Light**
Infiltration: **None** Pipe Seal Cond: **Sound**

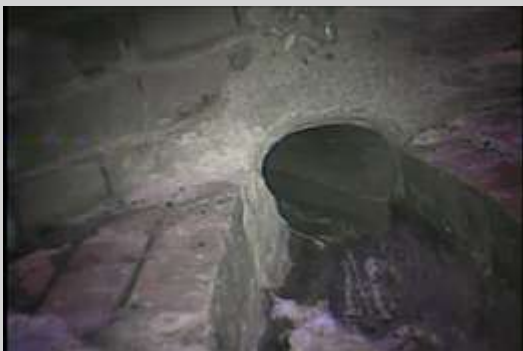
3 O'Clock Inflow

6 in. Circular Gravity Sewer
Pipe In @ 3 O'Clock

Pipe Height: **6** (in.) Rod and Bar (Angled)
Pipe Material: **Clay** ☐ Pipe Lined
Invert Depth: **11.34** (ft.) Flow Characteristics: **Slow**
Deposits: ☒ **None** ☐ Mud ☐ Sludge ☐ **Debris** ☐ Grease
Silt Depth: (in.) Deposits Extent:
Infiltration: **None** Pipe Seal Cond: **Sound**

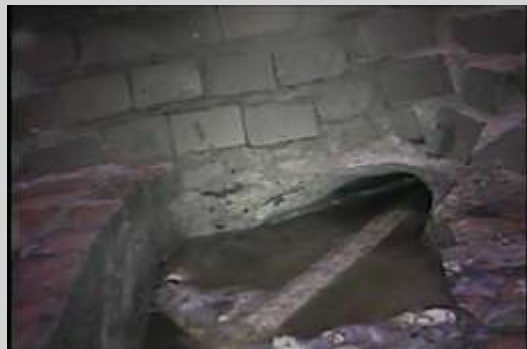
8 O'Clock Inflow

8 in. Circular Gravity Sewer
Pipe In @ 8 O'Clock

Deposits: ☐ None ☐ Mud ☐ Sludge ☒ **Debris** ☐ Grease

Silt Depth: **2** (in.) Deposits Extent: **Light**
